LEO JOURNAGAN LAKE
GREENE COUNTY, MISSOURI
MO 20395

**PHASE 1 INSPECTION REPORT
NATIONAL DAM SAFETY INSPECTION**

PHASE I INSPECTION REPORT
NATIONAL DAM SAFETY PROGRAM

Anderson Engineering, Inc. Springfield, Missouri
Hanson Engineers, Inc., Springfield, Illinois

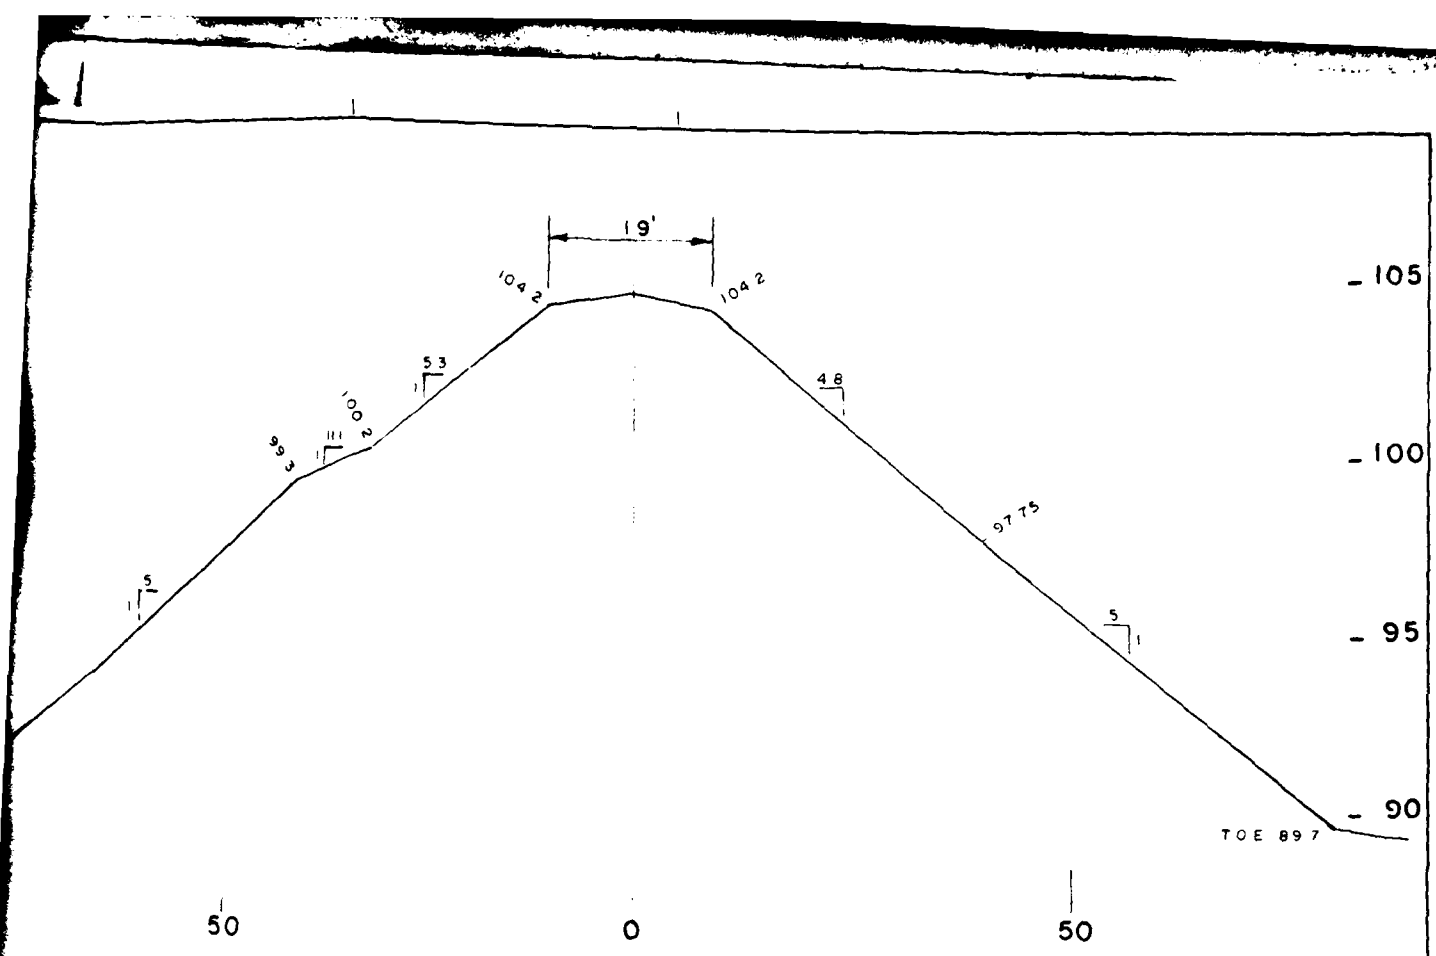
SECTION A-A STA 5+00

The Soil Conservation Service designed an embankment cross section which is shown on Sheet 5 of Appendix A. No other foundation or embankment design information was available. Information from the owner indicates that the dam is composed of silty clay soils from the lake area. There is apparently no particular zoning of the embankment and no internal drainage features are known to exist. No construction inspection test results have been obtained.

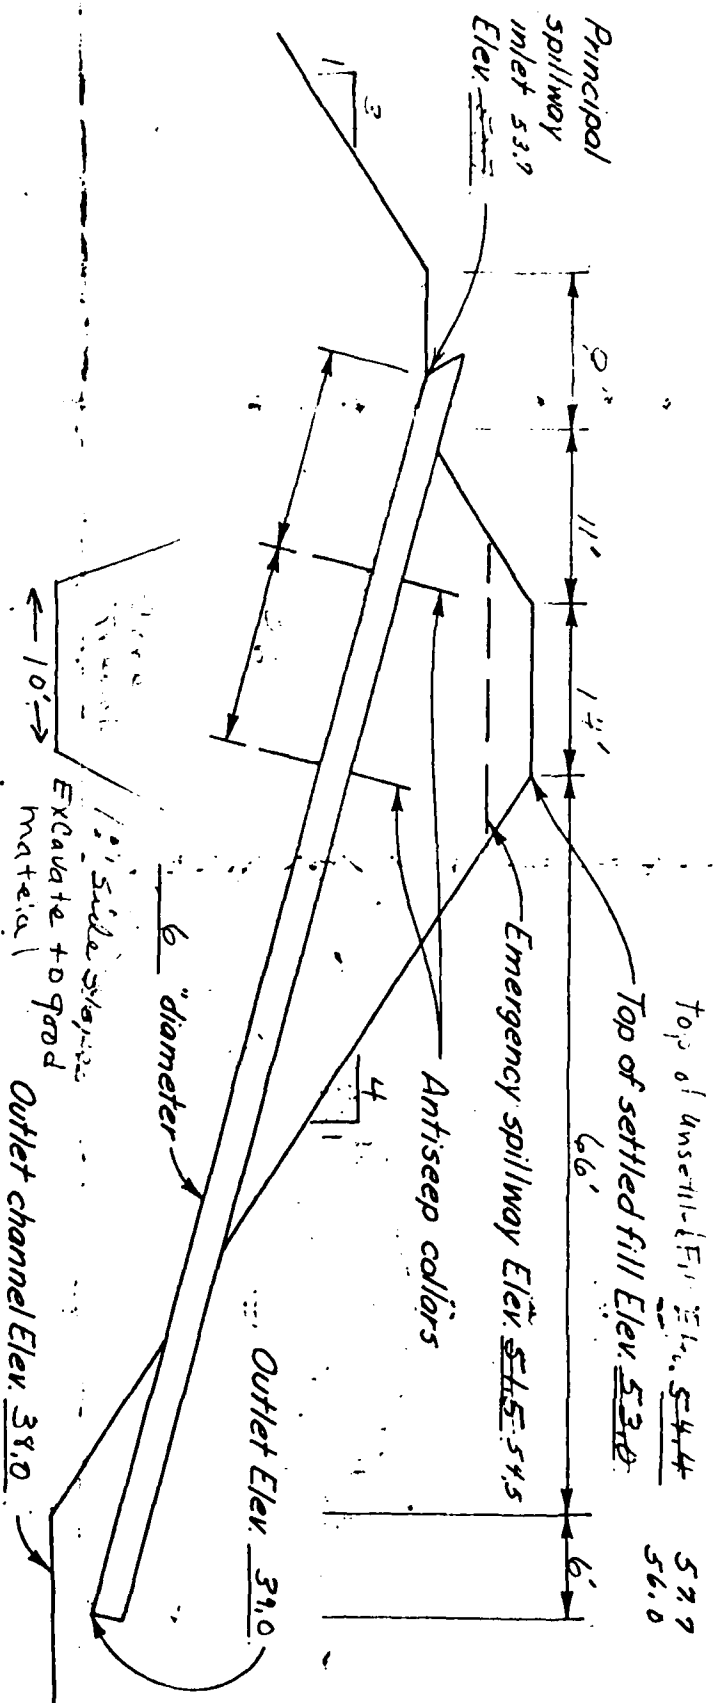
SECTION ALONG & PRINCIPAL SPILLWAY

The 6 1/4" primary spillway pipe was in good condition. The invert was clear, however no provision exists to prevent

The outlet of the 6 1/4 inch pipe was also in good condition. No water was noted in the pipe or at its contact with the embankment.
